Southern Star Inspections, LLC

Property Inspection Report

1234 New Street Dr., Tomball, TX 77377

Date of Inspection: 11/11/2013 Time: 10:00 a.m.

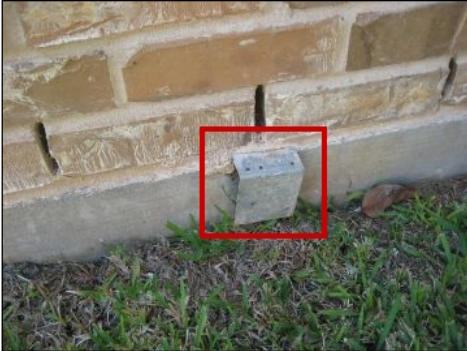
Remove mud sill anchor at the rear elevation of home

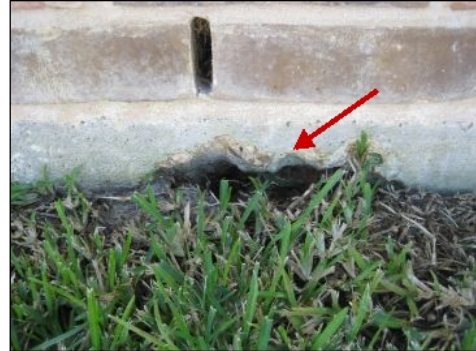
• Observed void in foundation at rear elevation of home under master bedroom windows. This should be filled so not to allow ponding water under foundation walls.

Void in foundation at rear elevation of home under master bedroom window

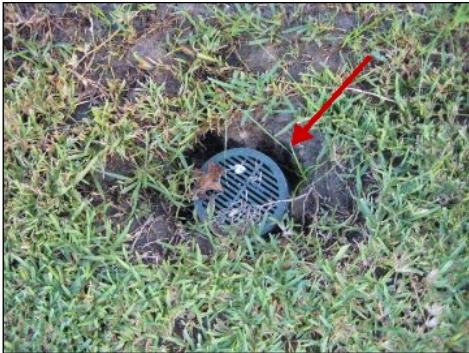
- **Excessive moisture and/or standing water was observed at the rear right elevation of the property at the time of inspection. The grading should be improved to promote the flow of storm water away from the house and off the lot.**

Grading void at drain on rear right elevation

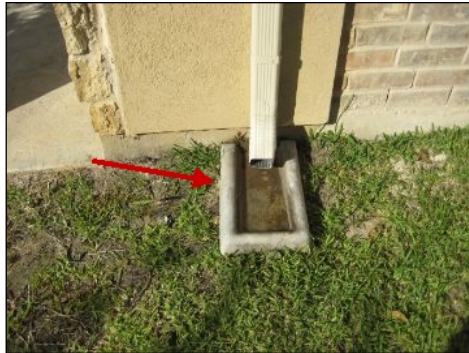
- **Full gutter system is installed at time of inspection. Splash blocks are present but several are installed incorrectly. Recommend turning so that the open end is facing away from the foundation.**

Splash blocks installed incorrectly

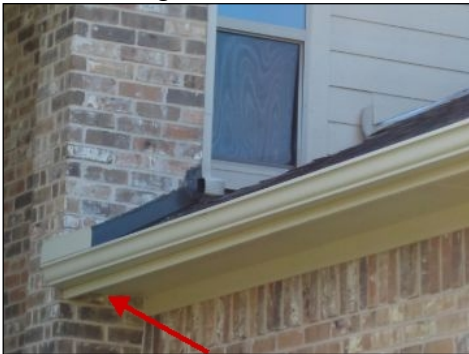
- **Recommend adding a gutter downspout at the rear elevation of home near the back patio to catch storm water from the "trap" area located over master bedroom roof covering.**

Recommend gutter down tube at rear elevation

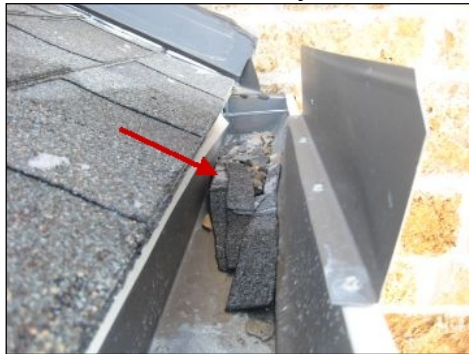
- **Gutters have debris and can possibly clog gutter down spout. Recommend periodically cleaning all gutters so that water is diverted away from foundation as intended.**

Construction debris in front elevation gutters

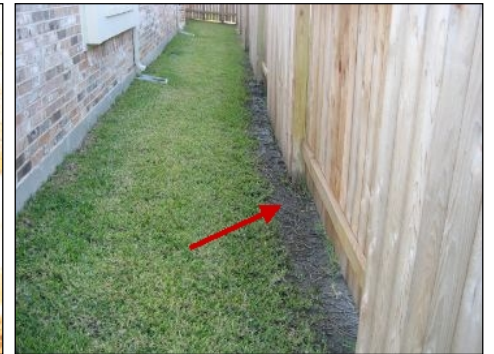
Moist area on left rear elevation fence line

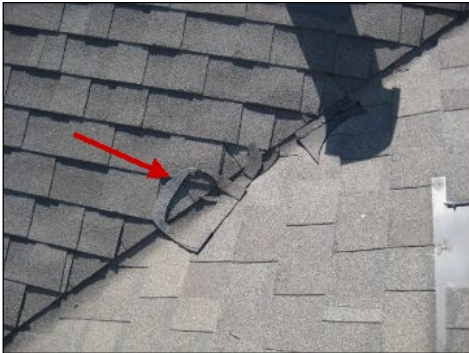
Debris on roof covering

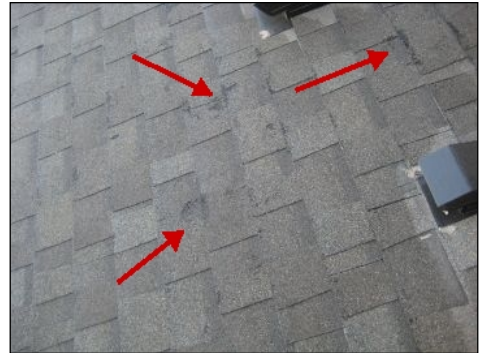
Deteriorated shingles at left elevation of home

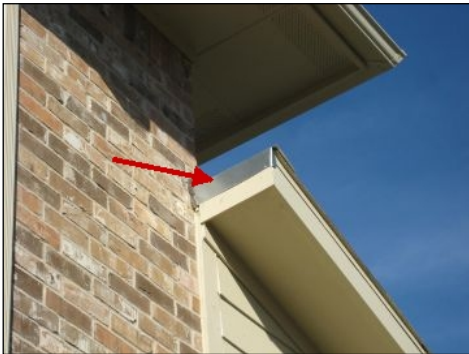
Flashing not painted at rear right elevation of home

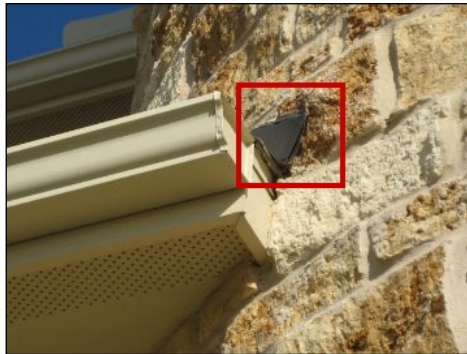
Missing kick out flashing at front elevation

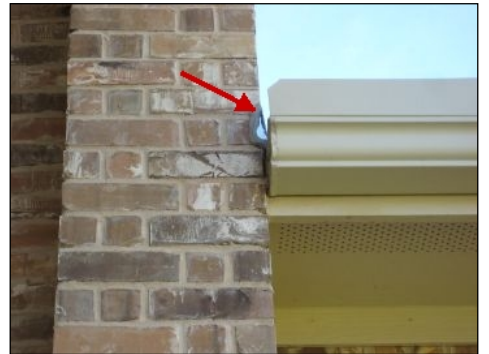
Missing kickout flashing at rear elevation near patio

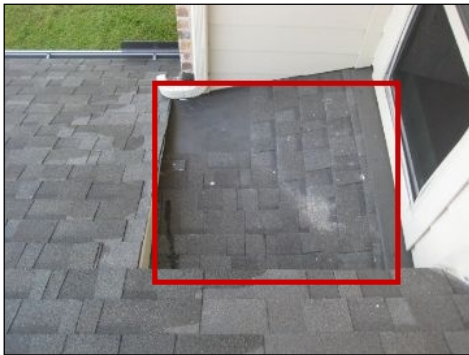
Monitor area for trapped debris/moisture

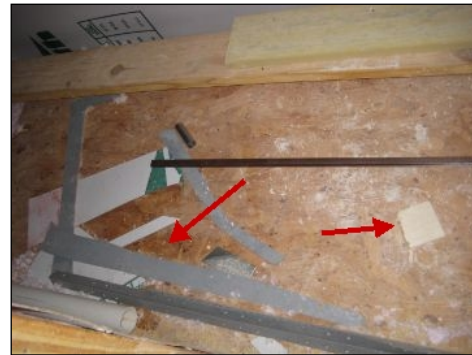
Debris in rear elevation walk in attic space

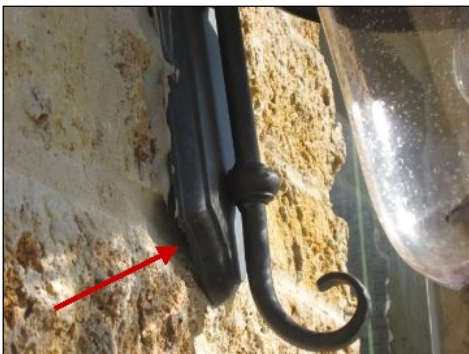
Seal around all exterior wall penetrations

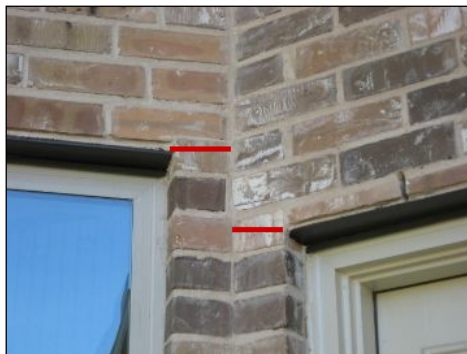
Lintels should have minimum 4" bearing

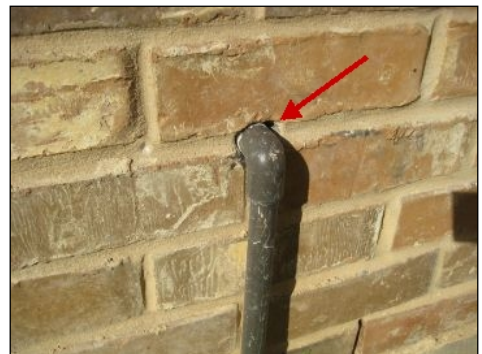
Seal sprinkler wire entry to home on right elevation

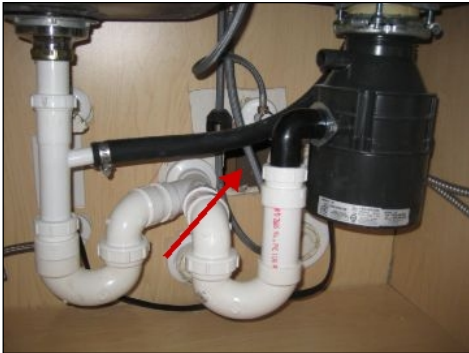
Seal gap under kitchen sink

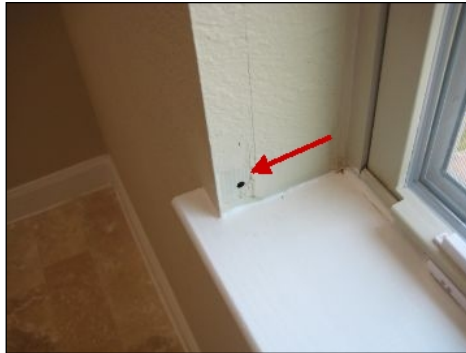
Drywall repair needed in utility room

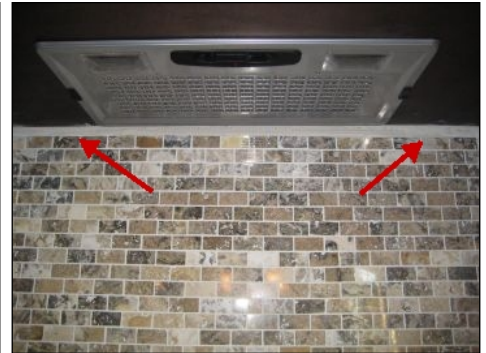
Tile backsplash not complete under vent hood in kitchen

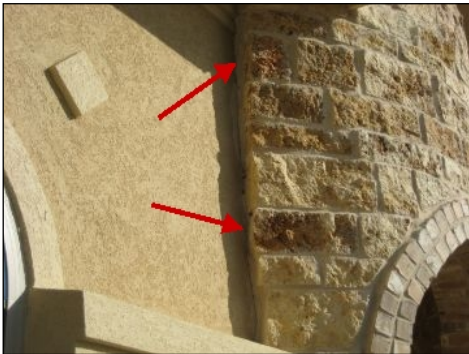
Seal crack at left of front entry

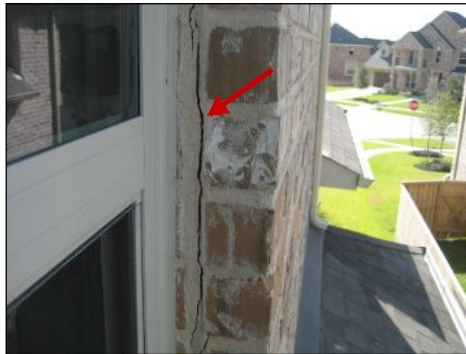
Crack in wall at second floor left elevation

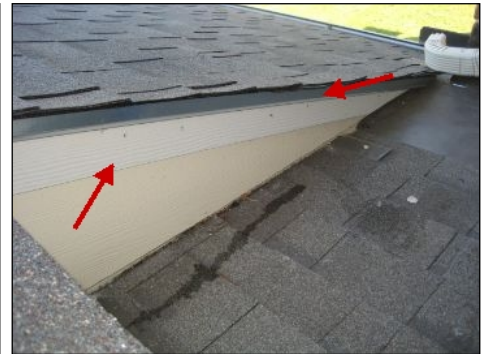
- Siding and drip edge flashing is not painted at the rear elevation of home over the master bedroom within the "trap" area.

Siding and flashing missing sealant/paint at rear elevation

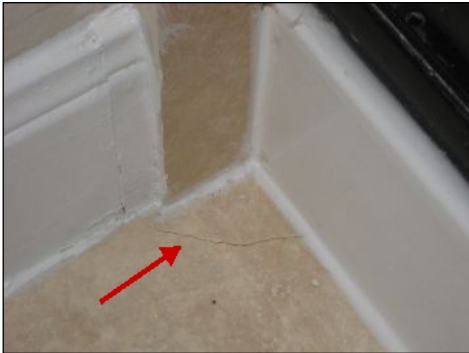
Cracked tile at front right bathroom

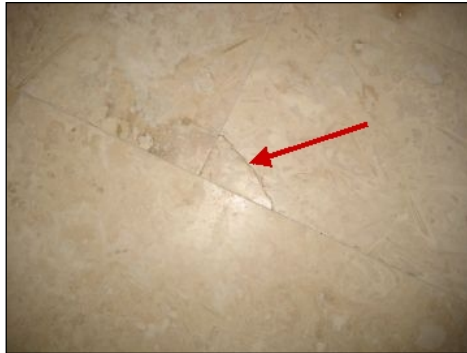
Cracked tile at living room floor

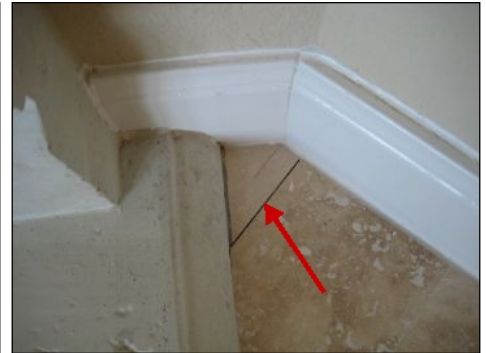
Crack in tile near fireplace

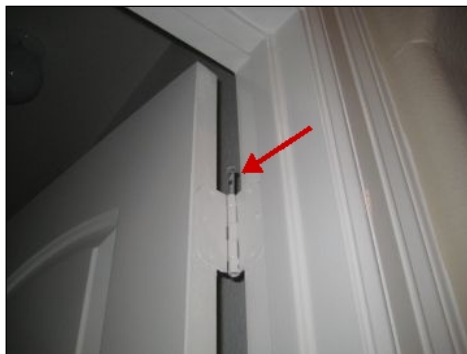
Hinge pin not secure at pantry door

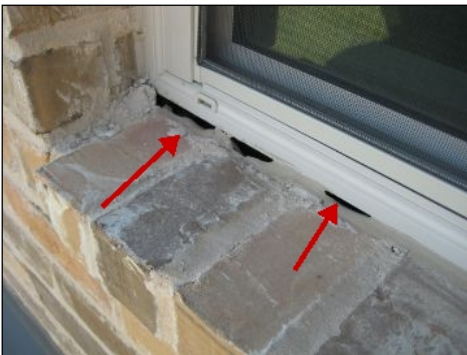
Gap at second story left elevation window

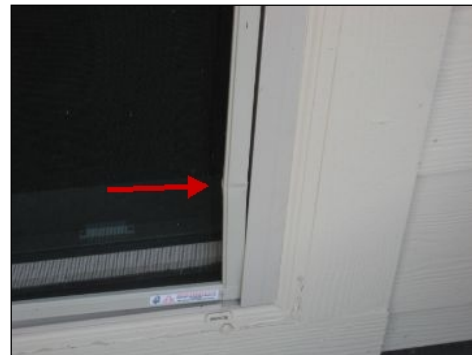
Damaged screen at second floor rear elevation

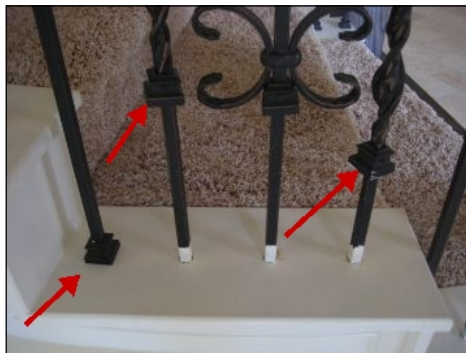
- **The spindle base caps are not secure in position.**

Spindles boots not secure

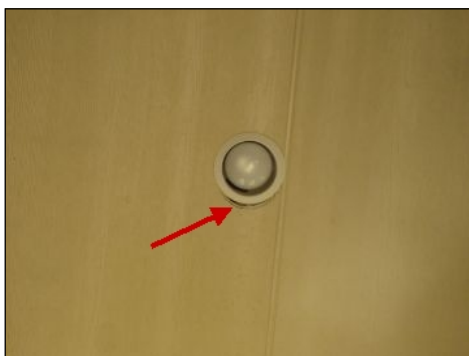
Gap at recess can light of front porch

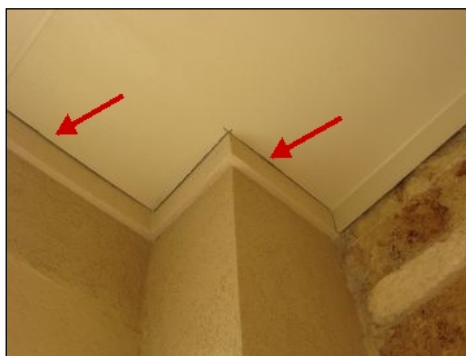
Seal gap at garage carport ceiling

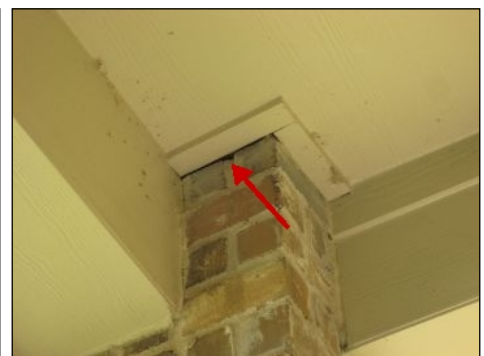
Seal gap at rear patio cover ceiling

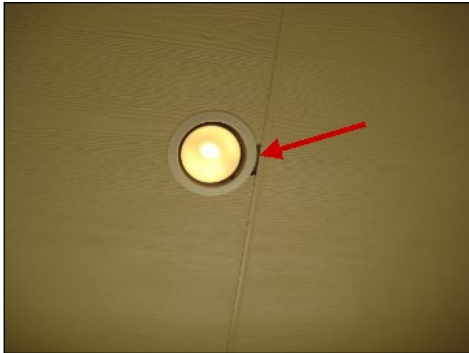
Gap in ceiling near light at balcony

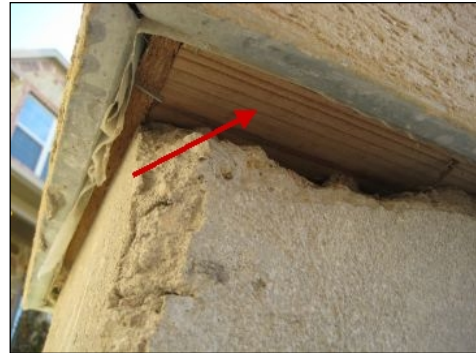
Exposed lumber at carport right column

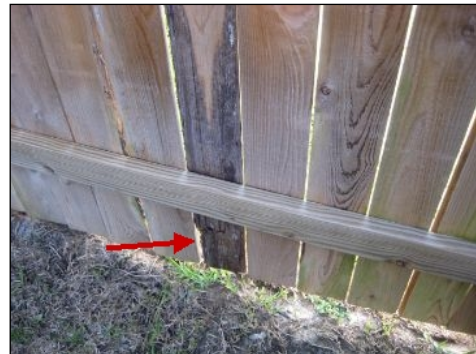
- **Fence picket at the left front elevation is deteriorated.**

Fence picket deteriorated at front left side

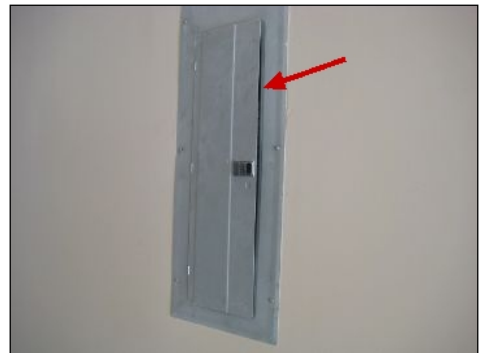
Main panel cover not closing

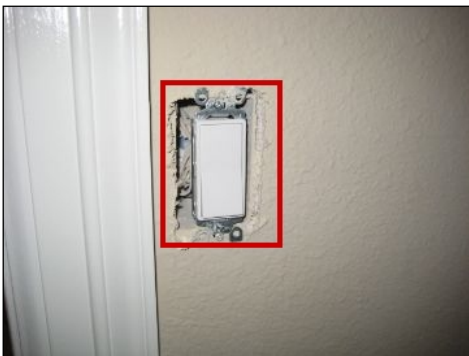
Missing light switch cover in coat closet

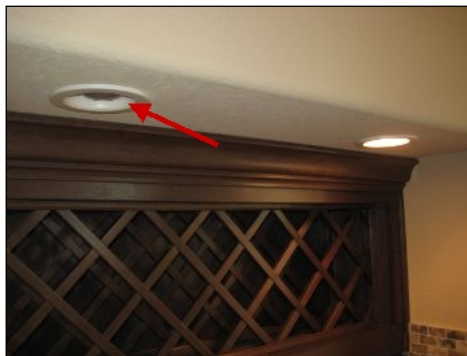
Light inop at wine bar in kitchen

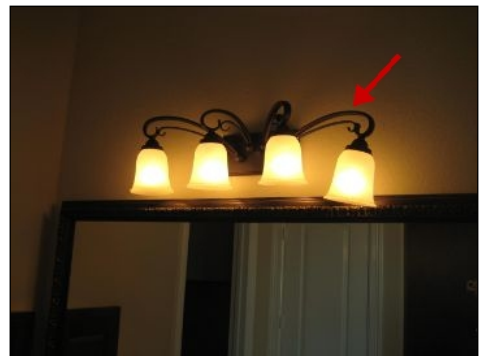
Master bathroom light not secure

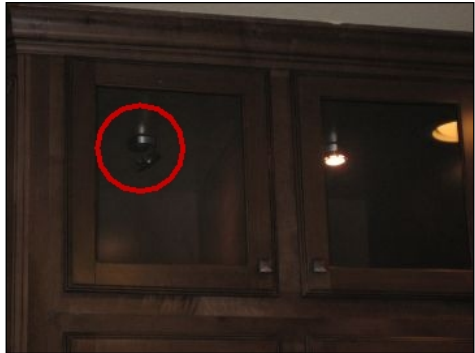
Light above fridge in cabinet inoperative

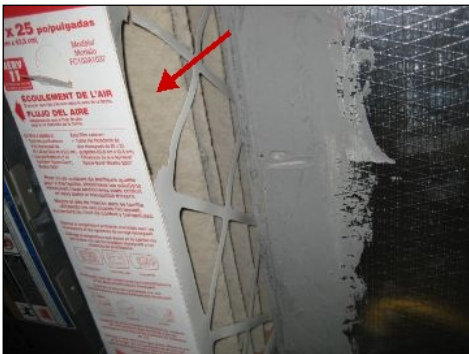
Recommend replacing HVAC filters at plenum

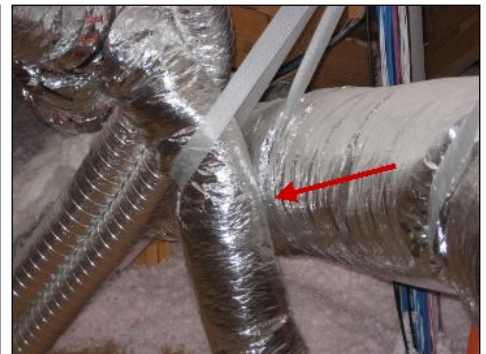
HVAC ducts in contact with one another

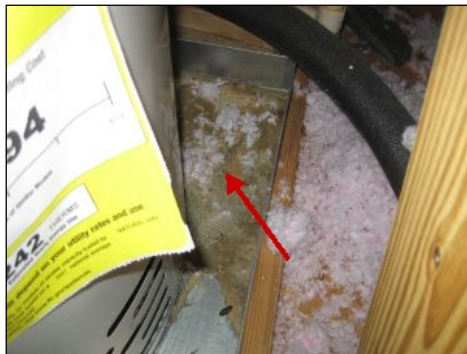
Debris in water heater drain pan

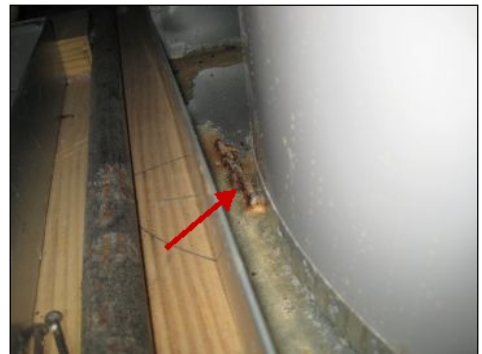
Debris in water heater drain pan

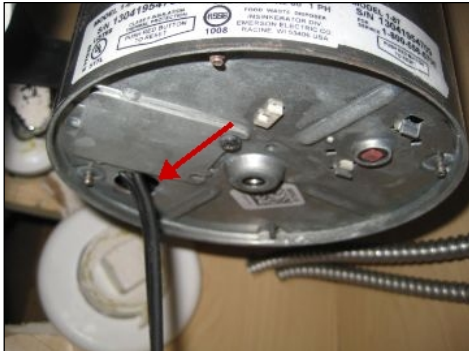
Disposer missing protective clamp

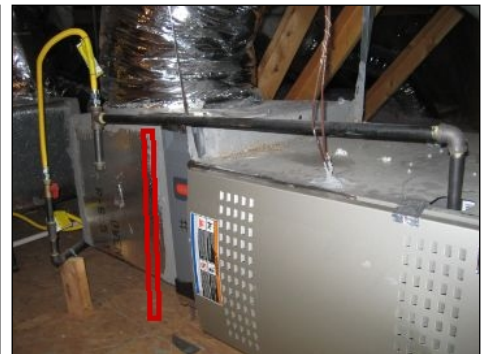
Support gas line to furnace in attic

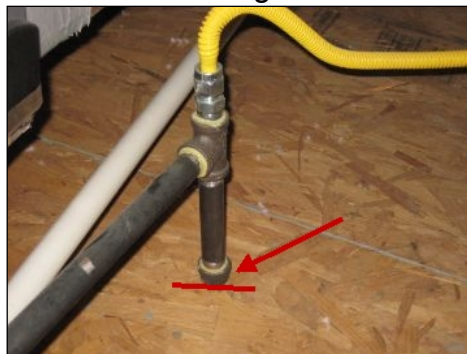
Unable to remove sediment trap cap at furnace
