Southern Star Inspections, LLC

Property Inspection Report

1234 New Street Dr., Tomball, TX 77377

Date of Inspection: 11/11/2013 Time: 10:00 a.m.

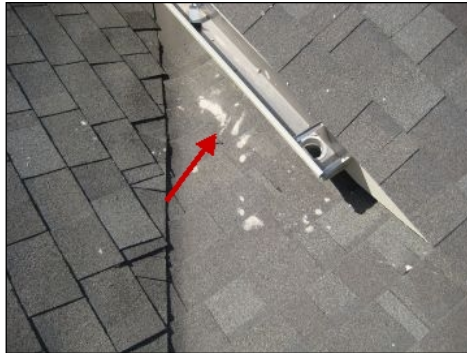
Paint/debris at front elevation

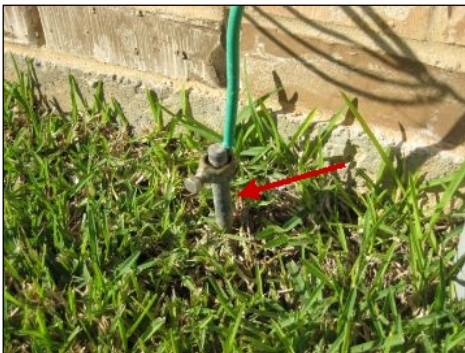
Lower ground rod at rear right elevation

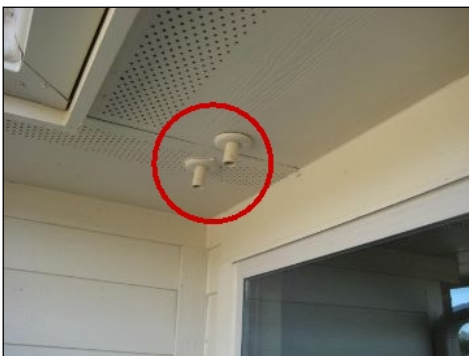
Secondary A/C drain lines at rear elevation

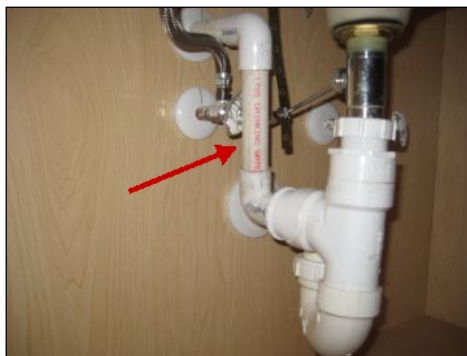
Primary A/C drain line at secondary bathroom

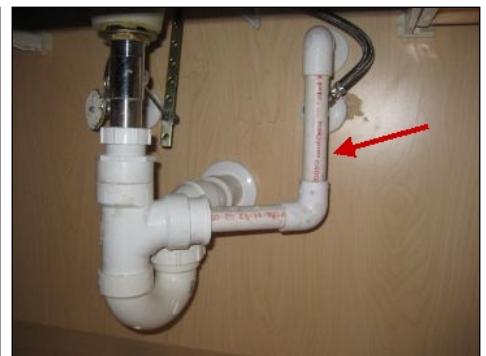
Primary A/C drain line at secondary bathroom

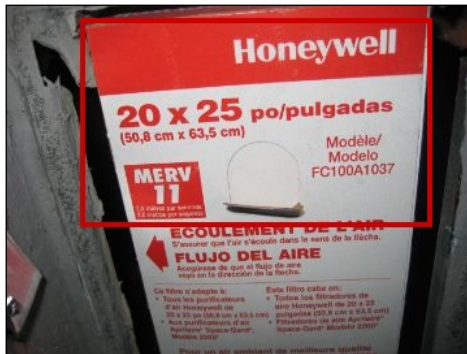
Filter size and type at plenums

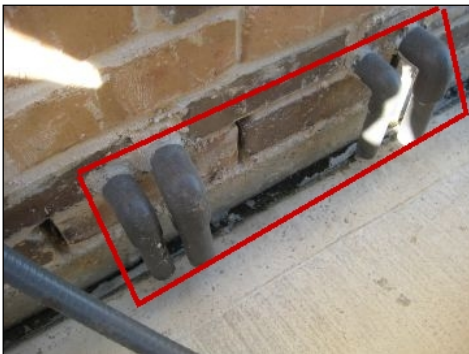
Water heater drain pipes at rear right elevation
