Southern Star Inspections, LLC

Property Inspection Report

1234 New Street Dr., Tomball, TX 77377

Date of Inspection: 11/11/2013 Time: 10:00 a.m.

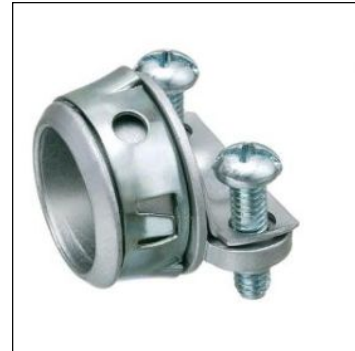
Disposer wire clamp
